## Harborview Mixed-Use

1200 Western Ave  
Seattle, WA 98101

Specified Inspection Platforms — Field Observation Report #4

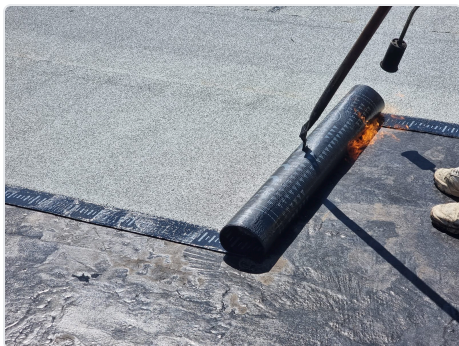
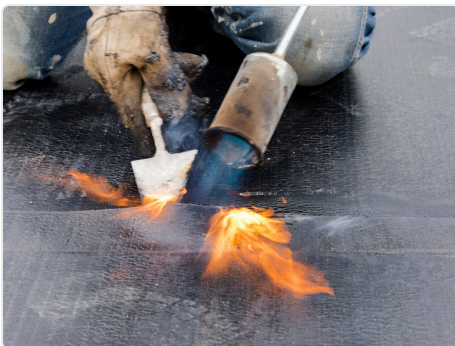
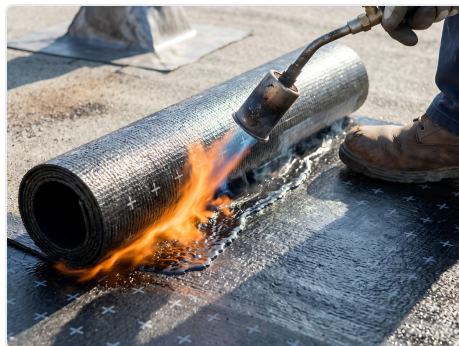
Side lap at the north area torched without consistent bleed-out; an unbonded edge about 4 ft long was found by probe. Contractor to reheat and seal the lap and probe the remaining laps before the cover.

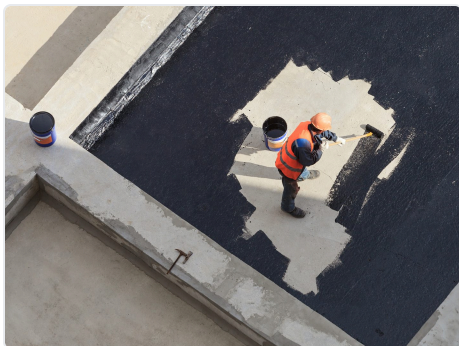
Liquid flashing at the RTU curb was applied to the deck only; the curb face and the top termination are not yet flashed.

Contractor to complete the curb flashing and terminate under the counterflashing.

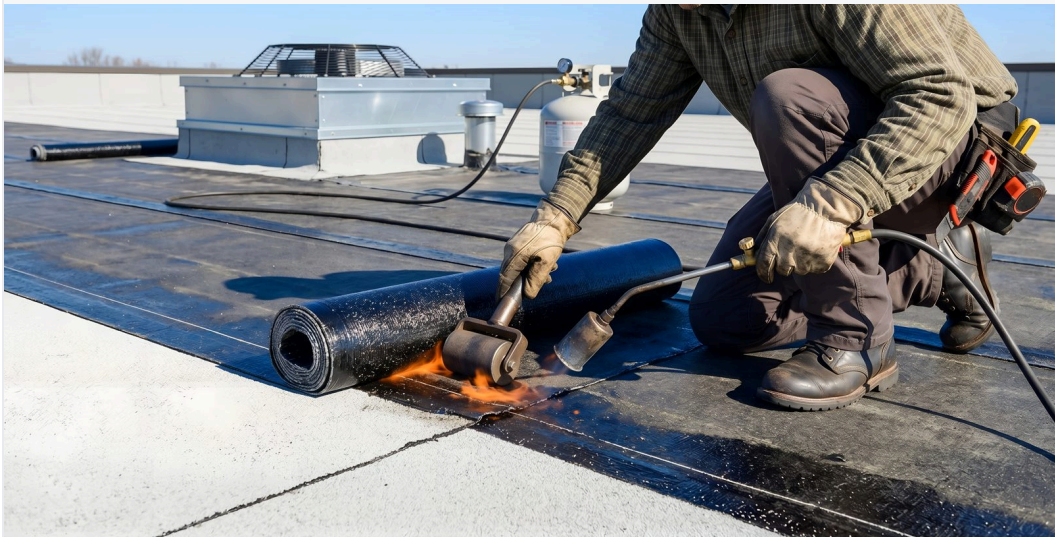
Photograph: 1

Cap sheet application

Cap sheet torch-applied over the base sheet at the north area; laps staggered from the base ply.

Cap sheet torch-applied over the base sheet; rolls aligned, laps staggered from the base ply, full bleed-out at the side laps where reviewed.

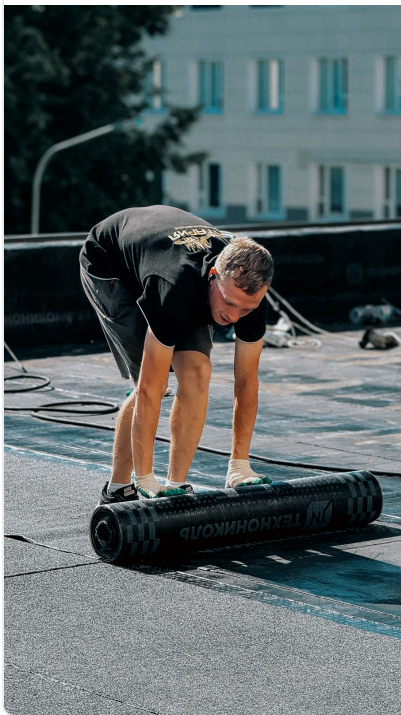
Photograph: 2

Rolling out the cap sheet

Roll aligned to the chalk line before torching; substrate swept and dry.

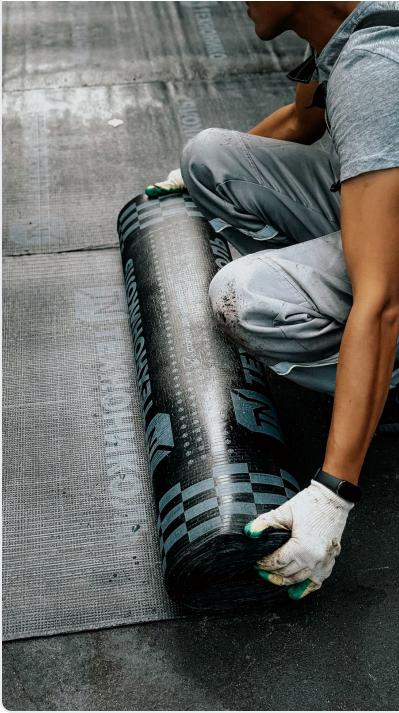
**Photograph: 3**

Cap sheet at the roll end

Roll end trimmed square; selvage edge clean for the next side lap.

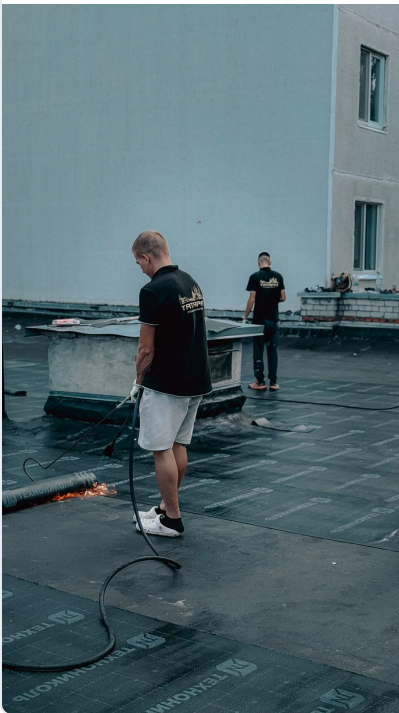
**Photograph: 4**

Work in progress, north area

Two applicators on the field membrane; fire watch equipment on the roof.

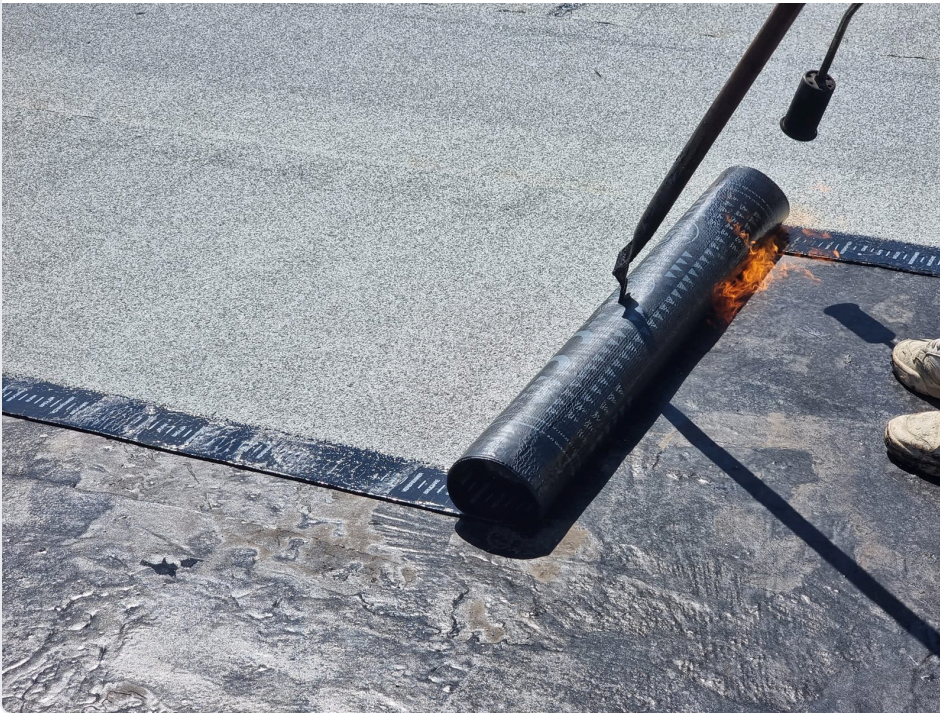
**Photograph:** 5

Side lap without bleed-out

Cap sheet side lap torched with no bleed-out along about 4 ft; the edge lifted under a probe.

Side lap at the north area torched without consistent bleed-out; an unbonded edge about 4 ft long was found by probe. Contractor to reheat and seal the lap and probe the remaining laps before the cover.

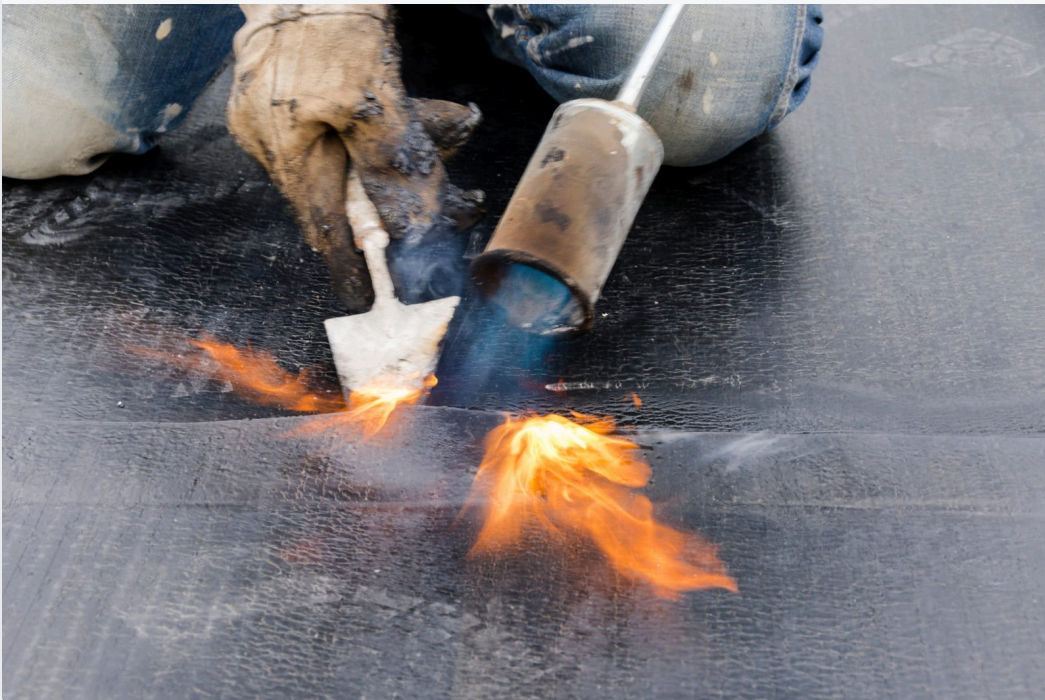
**Photograph:** 6

Torch at the lap

Lap being reheated and rolled after the probe.

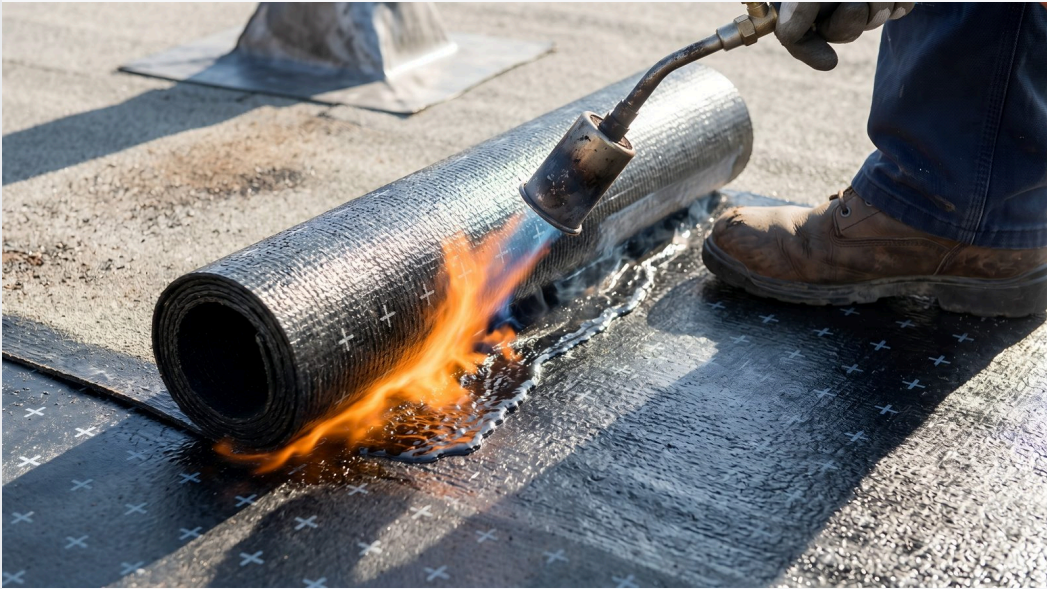
**Photograph:** 7

End lap being torched

End lap torched and rolled; bleed-out visible at the edge.

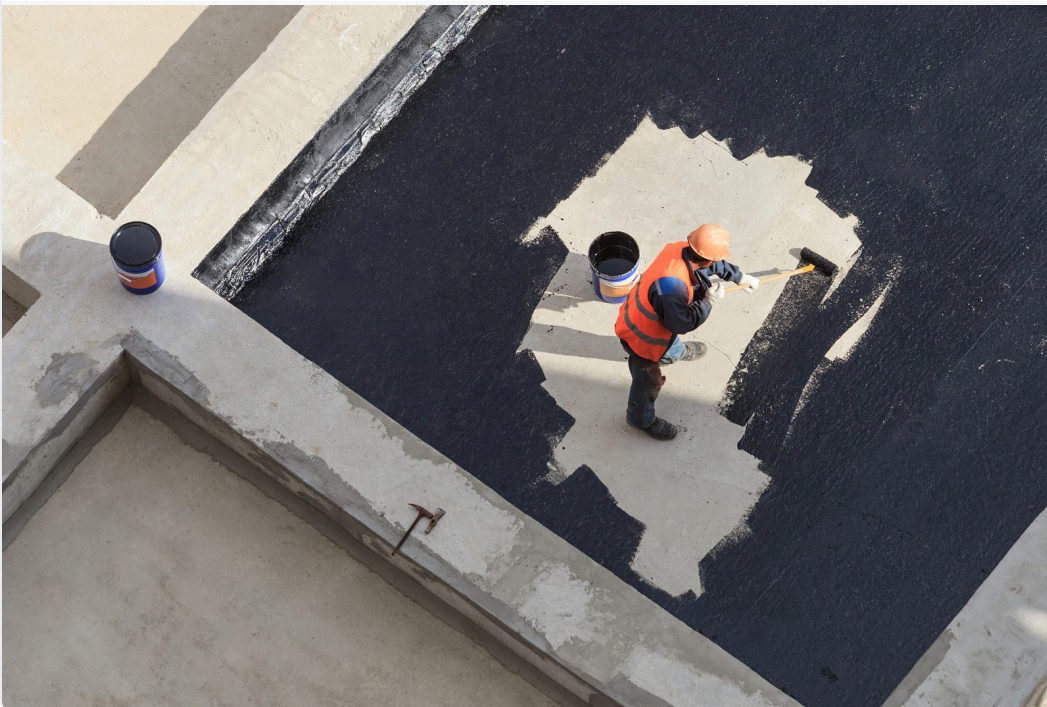
**Photograph:** 8

The curb detail shows the liquid flashing terminating under a counterflashing that is not shown on the mechanical drawings. Please confirm the counterflashing detail and who furnishes it.

RTU curb, liquid flashing

Liquid flashing applied around the curb at deck level; curb face and top termination outstanding.

Liquid flashing at the RTU curb was applied to the deck only; the curb face and the top termination are not yet flashed. Contractor to complete the curb flashing and terminate under the counterflashing.

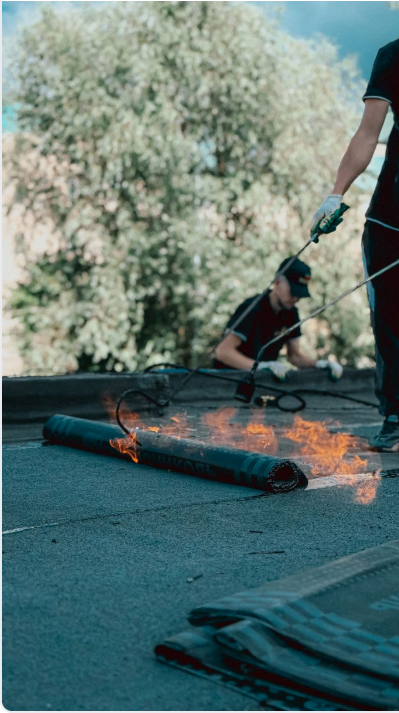
**Photograph: 9**

Torch application

Torch held to the roll with a continuous melt line ahead of it.

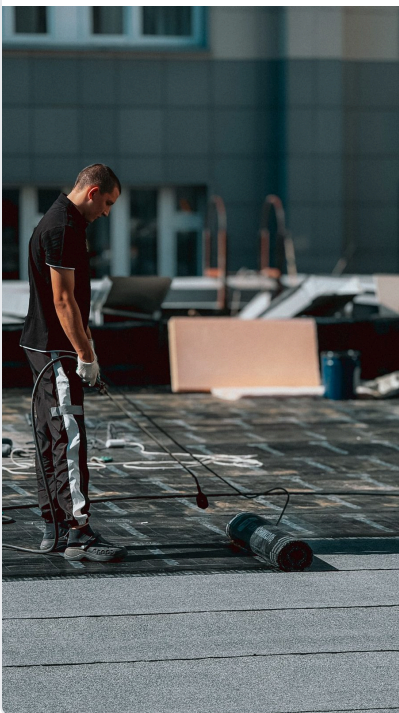
**Photograph: 10**

Set-up at the north area

Rolls staged and the field swept ahead of application.

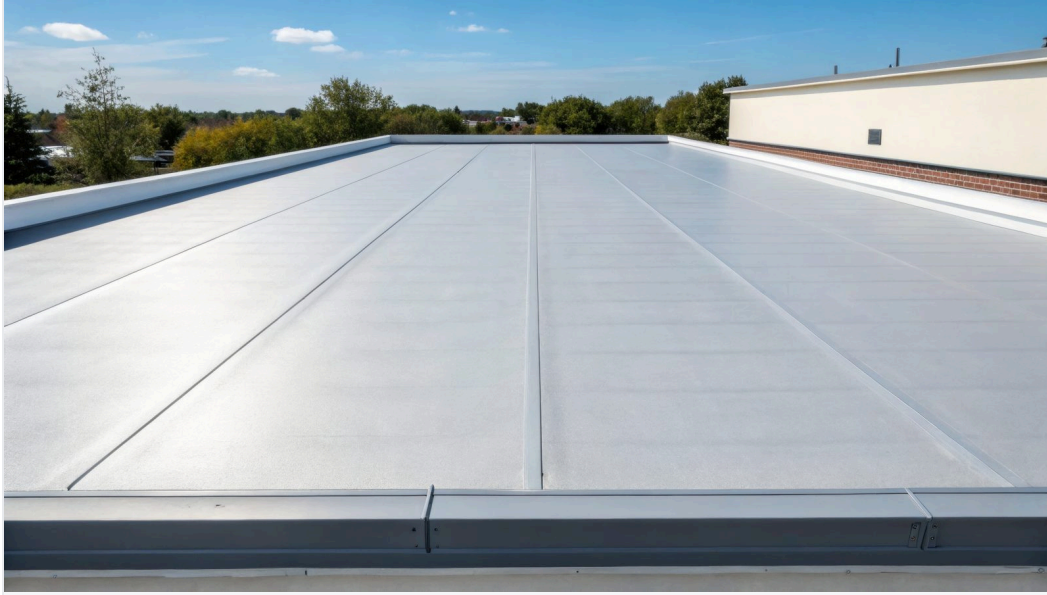
**Photograph:** 11

Completed single-ply roof, south penthouse

Field membrane complete; seams welded and probed; drains clear.
