## Harborview Mixed-Use

1200 Western Ave  
Seattle, WA 98101

Specified Inspection Platforms — Field Observation Report #4

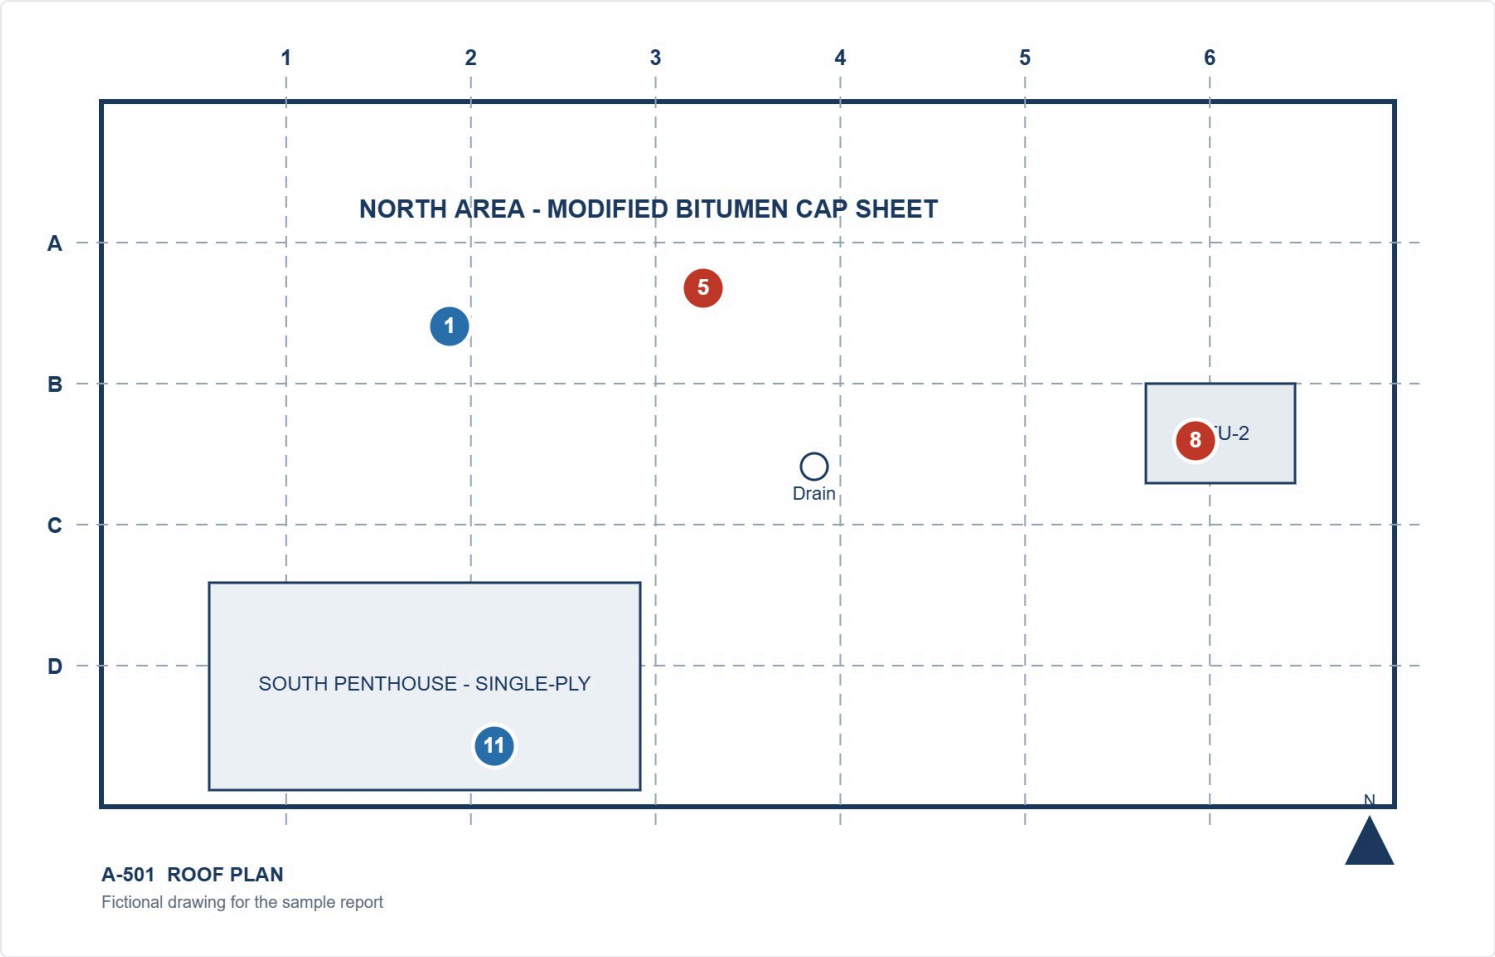
- PIN LEGEND · RED = ACTION ITEM BLUE = REFERENCE
- 1** Photograph 1 — Cap sheet application (North)

**5** Action Item 5 — Side lap without bleed-out (North)
- 8** Action Item 8 — RTU curb, liquid flashing (East)
